Manhole Inspection Summary

Manhole # S43KK_050MH

Insp Date: **8/13/08 11:01 AM**

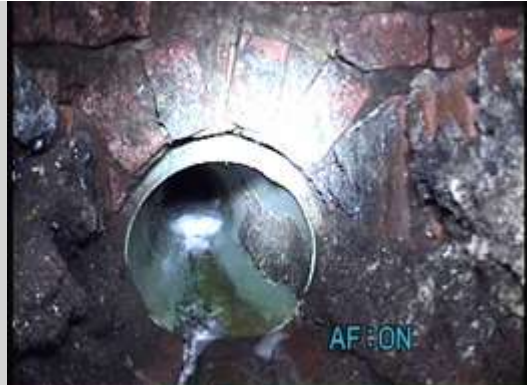
12 O'Clock Outflow

8 in. Circular Gravity Sewer
Pipe Out @ 12 O'Clock

Pipe Height: **8.4** (in.) Rod and Bar (Angled)
Pipe Material: **Clay** ☐ Pipe Lined
Invert Depth: **10.70** (ft.) Flow Characteristics: **Fast**
Deposits: ☒ None ☐ Mud ☐ Sludge ☐ Debris ☐ Grease
Silt Depth: (in.) Deposits Extent:
Infiltration: **None** Pipe Seal Cond: **Sound**

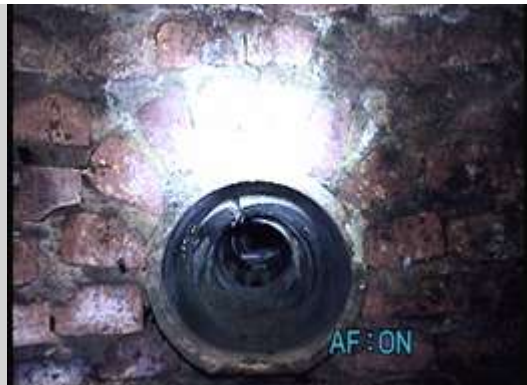
6 O'Clock Inflow

8 in. Circular Gravity Sewer
Pipe In @ 6 O'Clock

Drop In @ 6 O'Clock

Pipe Height: **8.4** (in.) Rod and Bar (Angled)
Pipe Material: **Clay** ☐ Pipe Lined
Invert Depth: **7.20** (ft.) Flow Characteristics: **Fast**
Deposits: ☒ None ☐ Mud ☐ Sludge ☐ Debris ☐ Grease
Silt Depth: (in.) Deposits Extent:
Infiltration: **None** Pipe Seal Cond: **Sound**

Drop: **Inside** Rod and Bar
Angled: **Yes** Reading: **9.25** (ft.)
Inv Depth: **10.25** (ft.)

Drop Condition: **Open**

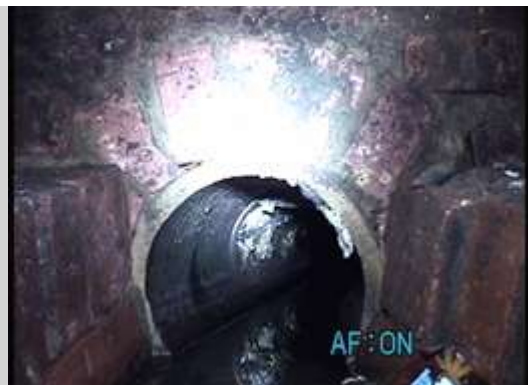
9 O'Clock Inflow

8 in. Circular Gravity Sewer

Pipe In @ 9 O'Clock

Pipe Height: **8.4** (in.) Rod and Bar (Angled)

Pipe Material: **Clay** ☐ Pipe Lined

Infiltration: **None** Pipe Seal Cond: **Sound**
